AERONAUTICAL MATERIALS LABORATORY

REPORT NO. NAEC-AML-2436

DATE 11 MAY 1966

DEVELOPMENT OF AN ENVIRONMENTAL WET TEST CHAMBER FOR
SIMULATING CARRIER DECK AND OTHER CORROSIVE ENVIRONMENTS

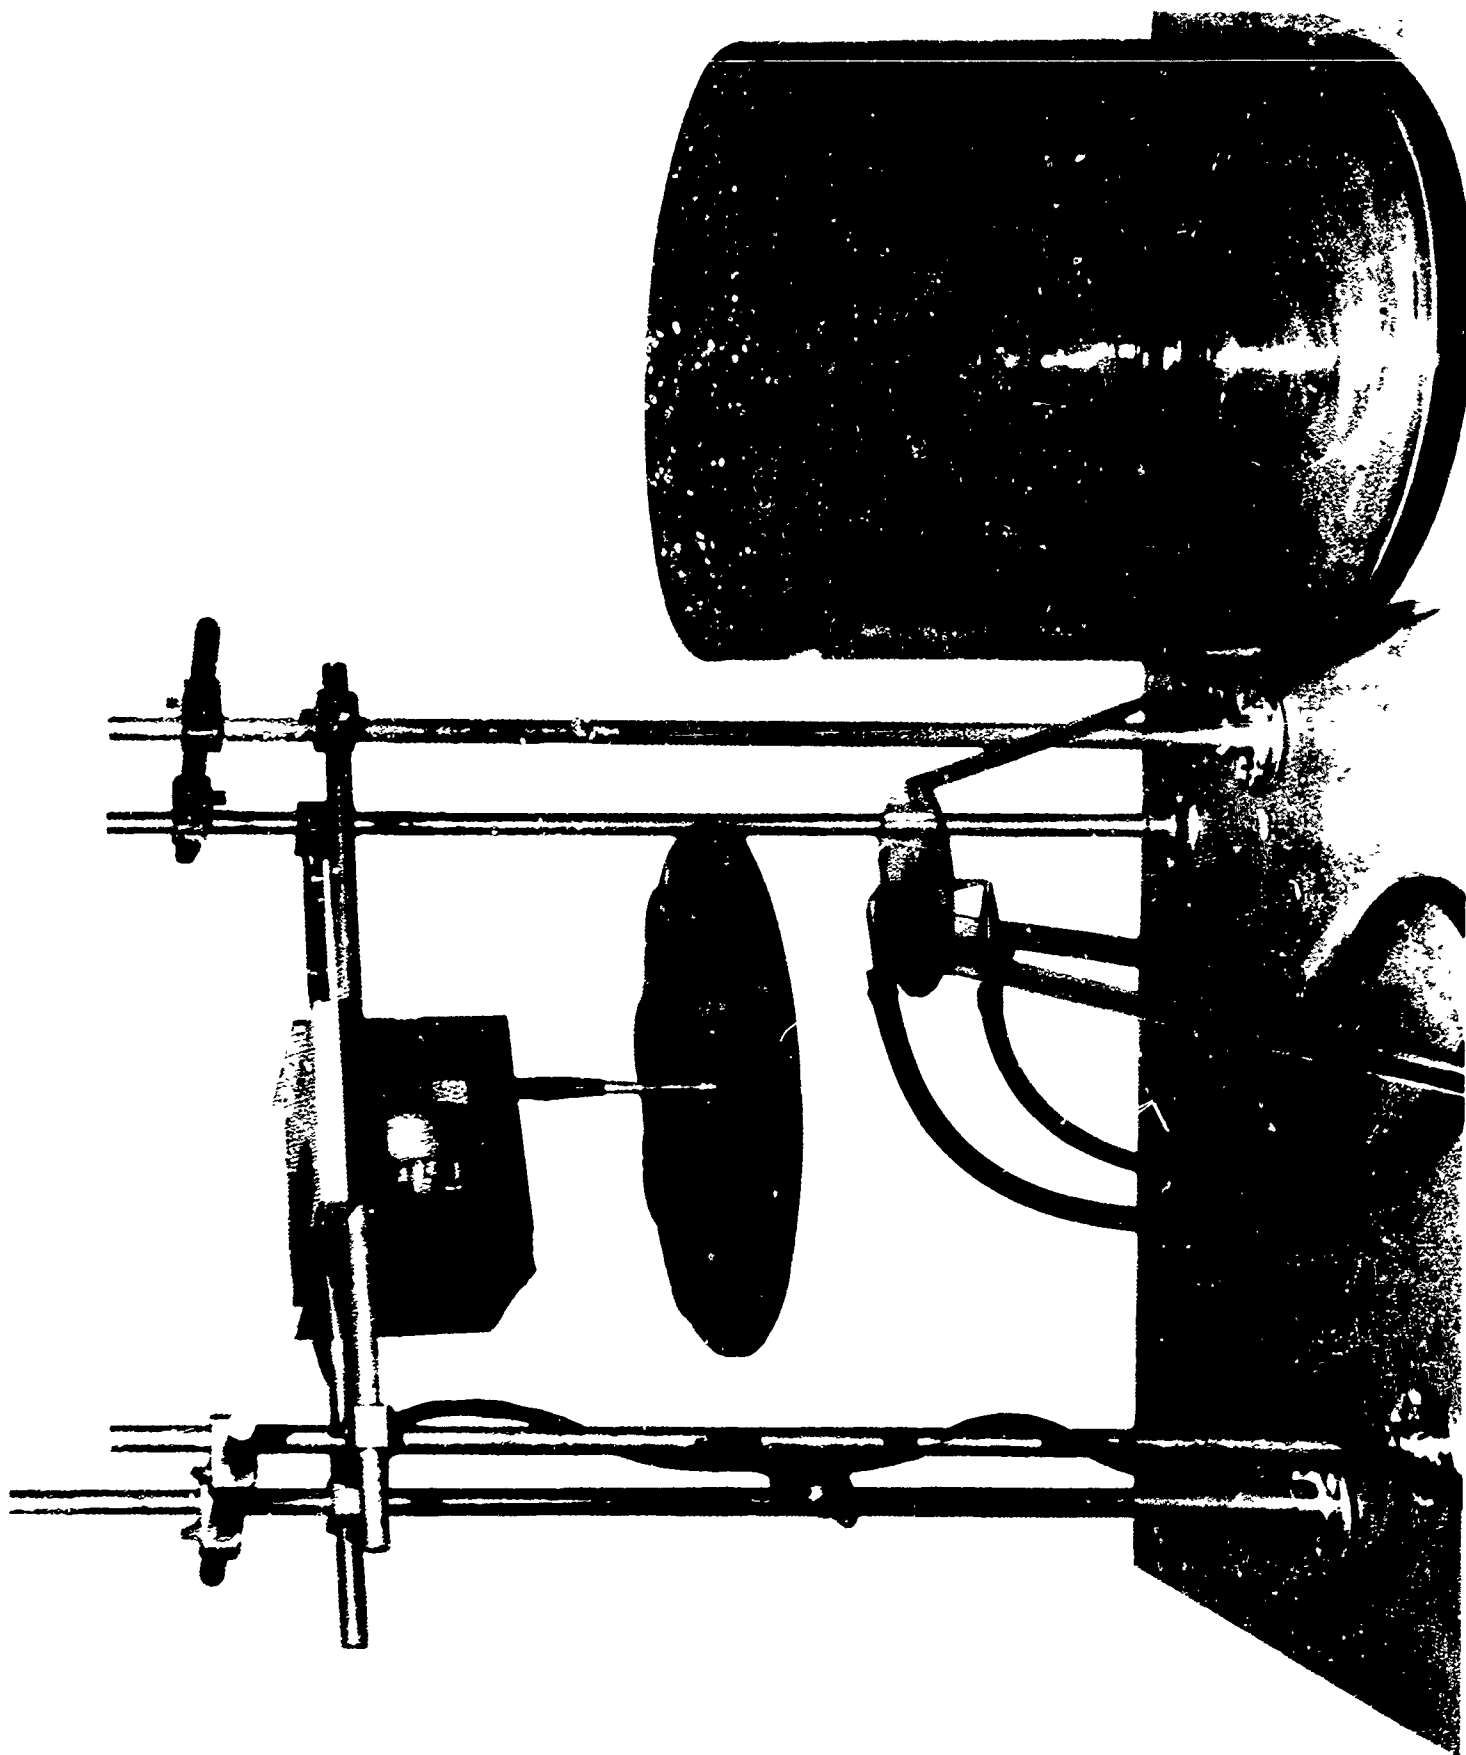
PLATE 1

COMPONENTS OF ENVIRONMENTAL WET TEST CHAMBER

The unit as shown in Plate 1 is composed of the following parts:

1. The test chamber consists of a glass jar twelve inches in diameter by twelve inches high.
2. A spray nozzle, employing two standard, glass eye droppers which are mounted in an acrylic holder as shown in Plate 1. It is important that the small diameters of the tubes be brought together as shown to effect proper spray pattern. Numerous commercial spray nozzles were tried but the fine orifices often clogged, especially when salt solutions were used. In addition they were fabricated, at least in part of metals, posing separate corrosion problems.

3. A tripod stand, made of acrylic plastic, which is a 4" dia. disc mounted on three narrow legs. It supports and positions the spray nozzle in the center of the chamber, eight inches from the bottom.

6. A turntable, fabricated from acrylic plastic is 9" in diameter by 3/8" thick. It is provided with nine evenly spaced 2-3/8" diameter x 1/4" deep sockets or wells, with center lines 1-7/16" from edge, which accommodates the mounted specimens. The bottoms of the wells are provided with a 1-7/8" diameter hole. A 1/4" diameter center shaft couples the turntable to a drive motor.

7. Drive Motor - 110VAC, 60 cycle; gear ratio = 9800:1; rpm = 1/3; output rotation = CW; 1/4" drive shaft with 1-1/8" exposed for coupling.
8. A motor housing was fabricated of 1/8" acrylic to protect the motor from vapors escaping from the chamber.

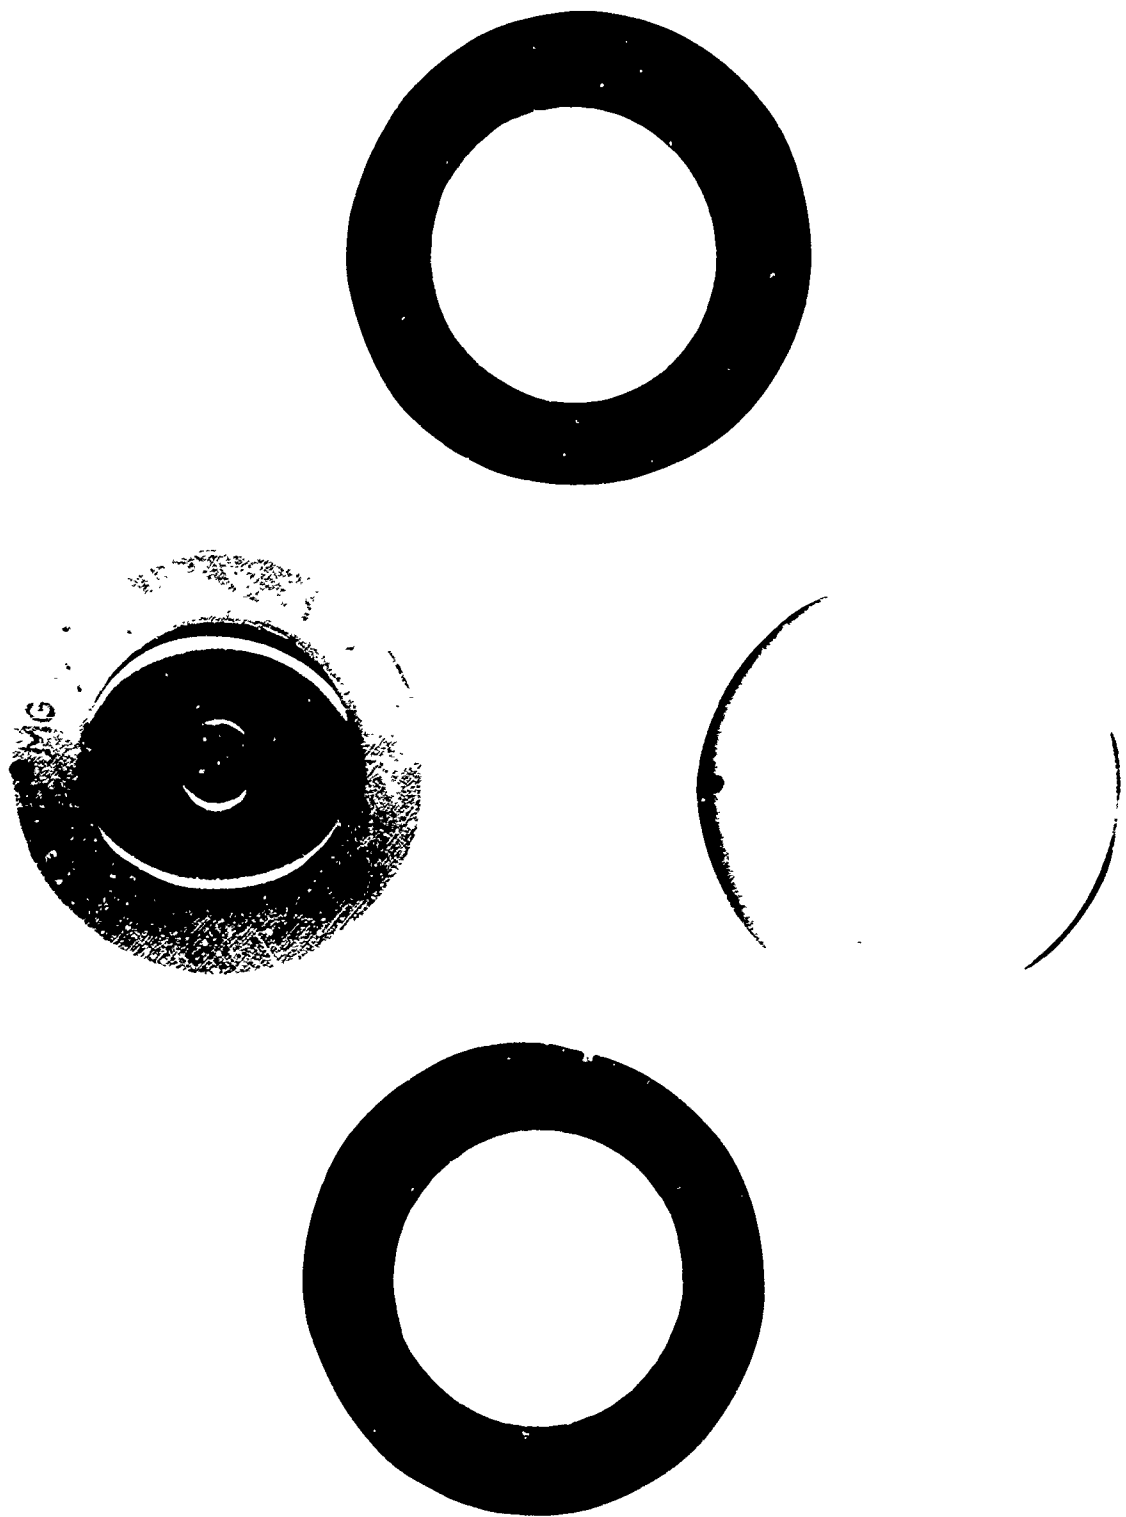
PLATE 3

DISSIMILAR METAL SPECIMEN, STEEL SPECIMEN, FRONT AND REVERSE VIEWS OF
SPECIMEN HOLDER

The specimens (Plate 3) used in the evaluation of the unit were:

1. 1020 steel, cold rolled conforming to specification MIL-S-7952, measuring 2-1/8" diameter x 1/16" thick, which were surface ground on one side (test surface).

2. Dissimilar metal specimens which consisted of two magnesium discs, one, 2-1/8" dia. x 1/16" thick, and the other 1" dia. x 1/8" thick, fastened together with a steel screw. The purpose of the larger disc was to provide proper fit in the specimen holder mount. The magnesium conformed to specification AZ31, H-24 and the screw was an AN510, flat head, from which the cadmium plating had been stripped. All specimen test surfaces were hand polished with 240 grit aluminum oxide cloth to a surface finish of 10-20 microinches, immediately prior to testing.

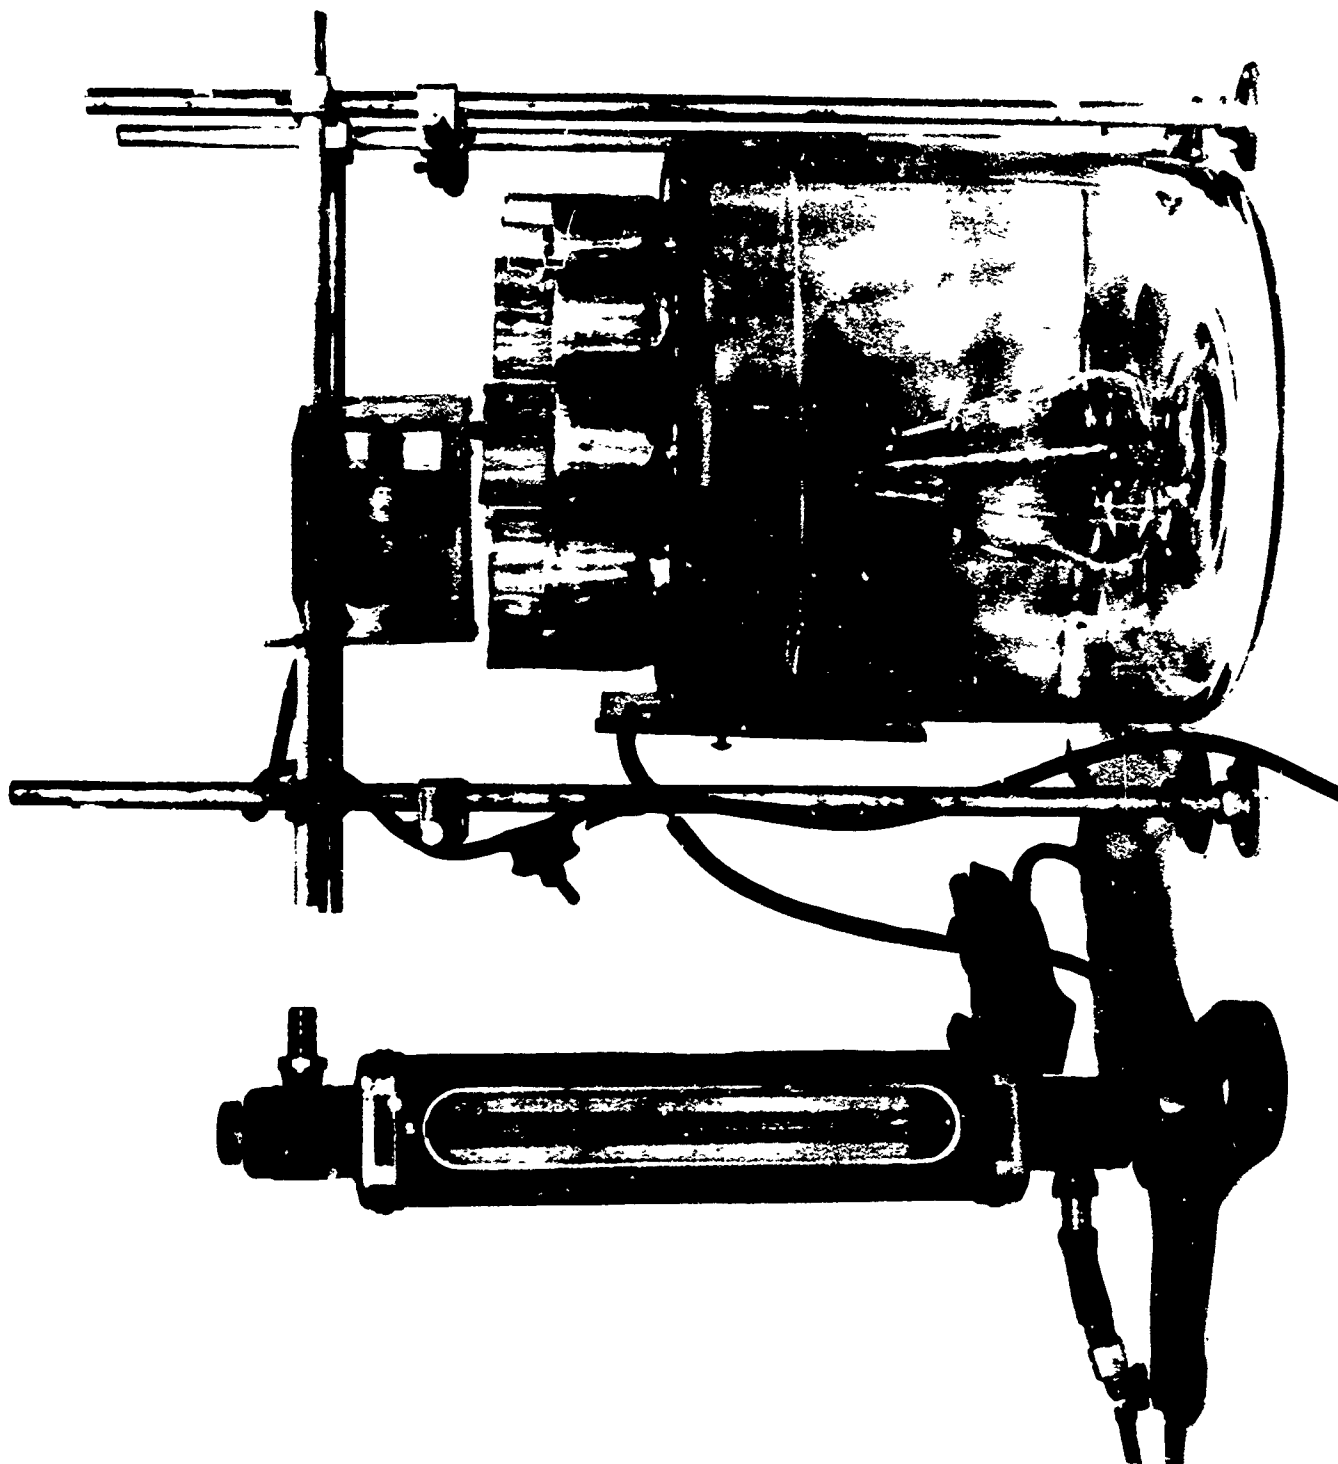
PLATE 4

OPERATIONAL ASSEMBLY VIEW OF WET TEST CHAMBER

The preliminary investigational work was done with the unit assembled as shown in Plate 4. The significant feature of this set-up was the plastic baffle located about 3" from the specimen. Approximately one liter of the corrodent was placed in the flask and the spray was started with the filtered air from the laboratory air supply metered at one cfm. The resultant fog filled the chamber. Fifty milliliters of cold water (35°F) was put into the aluminum sleeve which was placed in the specimen jar in contact with the back of the specimen in order to effect condensation on the face of the specimen.

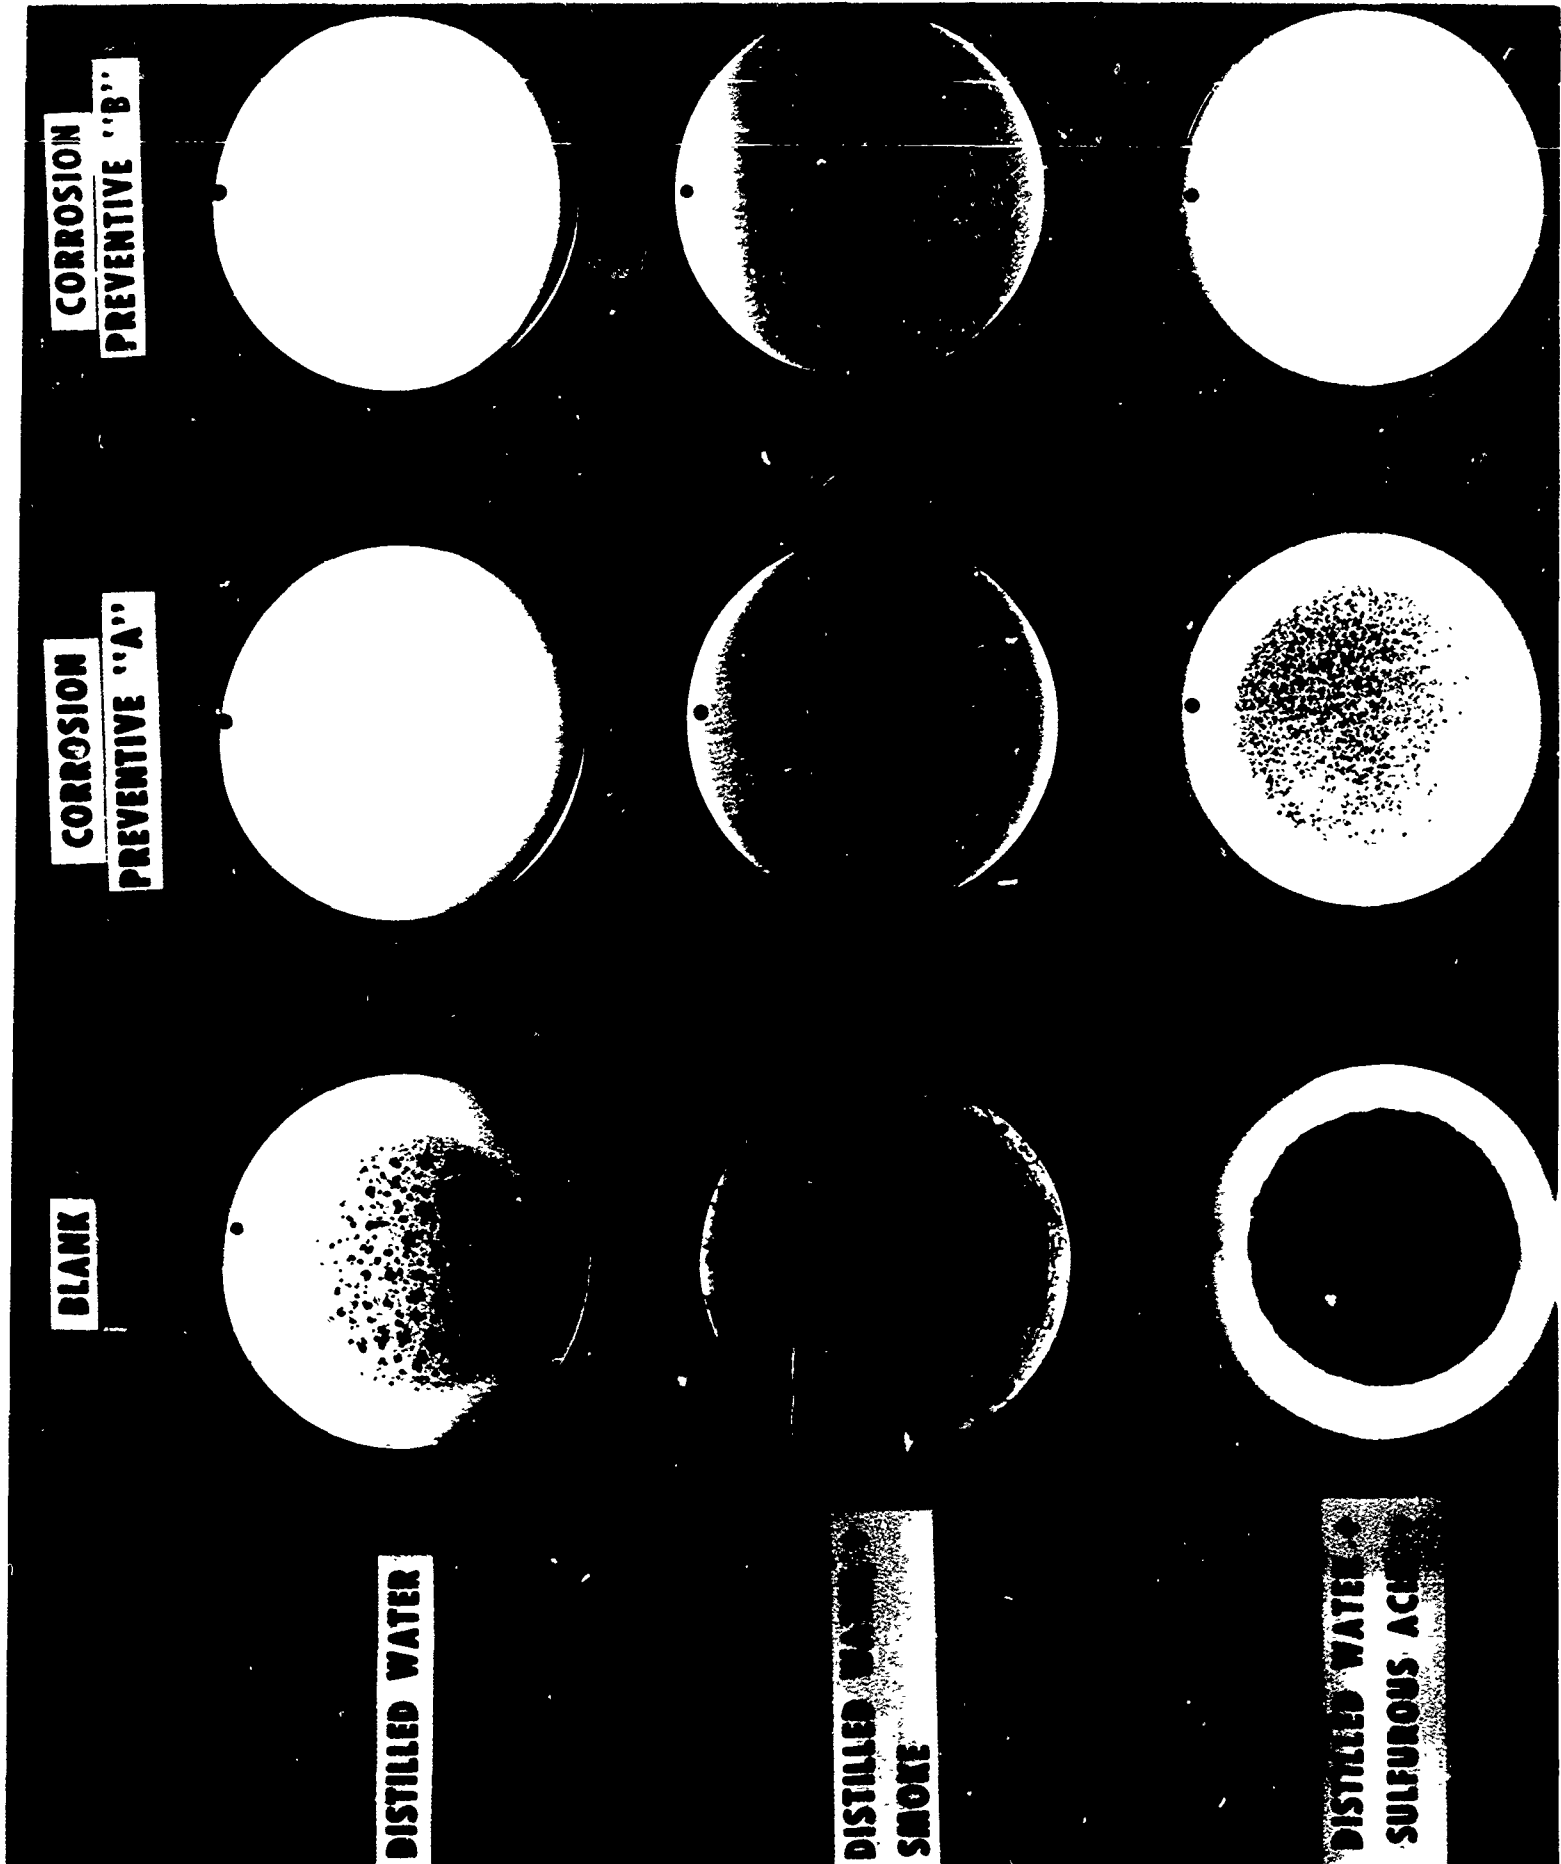
PLATE 6

RESULTS OF EXPOSURE OF STEEL SPECIMENS TO DISTILLED WATER, DISTILLED WATER/SMOKE, AND DISTILLED WATER/ACID ENVIRONMENTS

For the first environment, a fog was created by spraying distilled water into the chamber. The blank steel specimens used in the test displayed a moderate and uniform corrosion pattern at the end of the cycle consisting of 1 hour fog exposure and 3 hours drying. The next step was to simulate an industrial atmosphere. Here, in addition to a high humidity problem there are corrosive products of combustion such as smokestack gases to consider.

In order to simulate this condition, diesel fuel contained in a Cleveland open flash cup was ignited and permitted to burn freely. The smoke and combustion products were pulled into the chamber via a blower and duct system where they were mixed with the water spray (Plate 5). This environment was more severe than that produced by distilled water fog alone as evidenced by more pronounced pitting and discoloration of both the steel blank and the dissimilar metal specimens, shown in Plates 6 and 9.

similarity of the corrosion patterns, that the sulfurous acid could be substituted for the burning diesel fuel. Results are illustrated in Plates 6 and 9 where corrosion patterns are comparable.

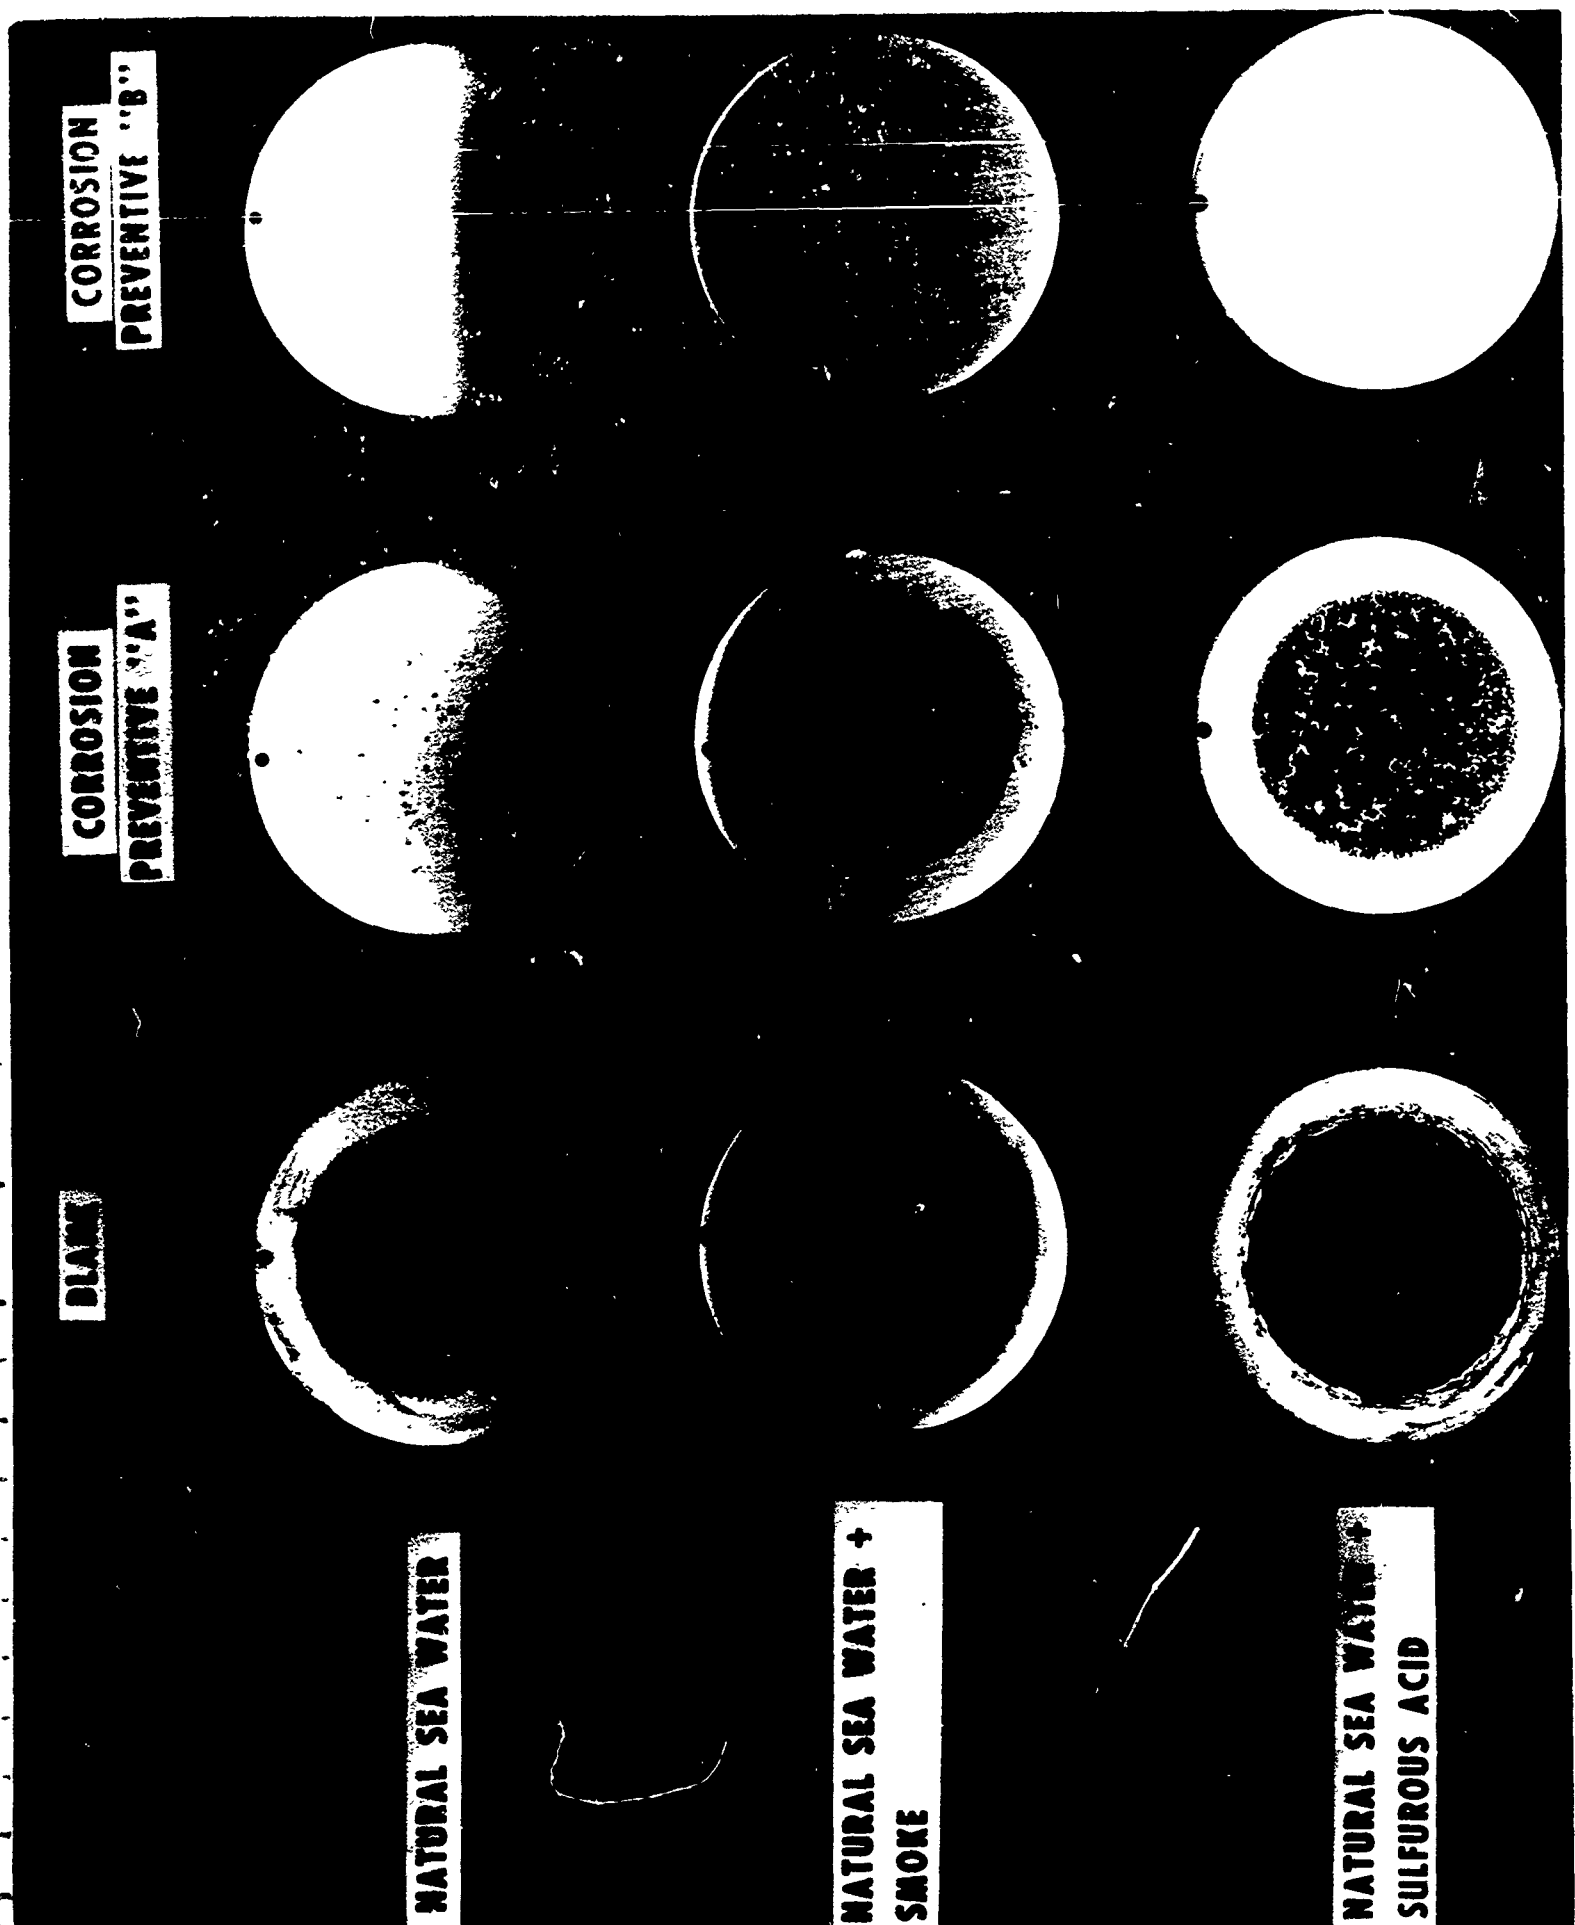
PLATE 7

RESULTS OF EXPOSURE OF STEEL SPECIMENS TO NATURAL SEA WATER, NATURAL SEA WATER/ SMOKE, AND NATURAL SEA WATER/ACID ENVIRONMENTS

Simulation of a coastal atmosphere, was accomplished by using natural sea water spray in the chamber. The sea water was obtained from Atlantic City, New Jersey. The results of this test are shown on the blanks illustrated in Plates 7 and 10 whereby the corrosive effects of salt water are evident. This can be more readily seen on the dissimilar metal specimen in Plate 12 where the galvanic action produced a heavy deposit of magnesium oxide at the peripheral edge of the magnesium disc in contact with the steel.

The inclusion of shipboard type environments was one of the main objectives of this investigation. Here again, in addition to sea spray mist, the smoke stack gases are present. This condition was simulated by employing the diesel fuel burner and associated gear (Plate 5) that was used previously. The smoke and the natural sea water spray, delivered simultaneously in the chamber, resulted in a combination of dense fog and smoke. The results of exposure to this environment demonstrated the effect of combining the two corrodents, manifested by a heavier corrosion pattern and overall discoloration of the test specimens (Plates 7 and 10).

A critical comparison of the specimens exposed to the natural sea water environments with those exposed to the synthetic sea water environments showed that with the latter the corrosion appeared to be more severe but the difference was insignificant. This demonstrated the feasibility of using synthetic sea water in tests simulating coastal or shipboard atmospheres. The specimens referred to are shown in Plates 7, 8, 10 and 11.

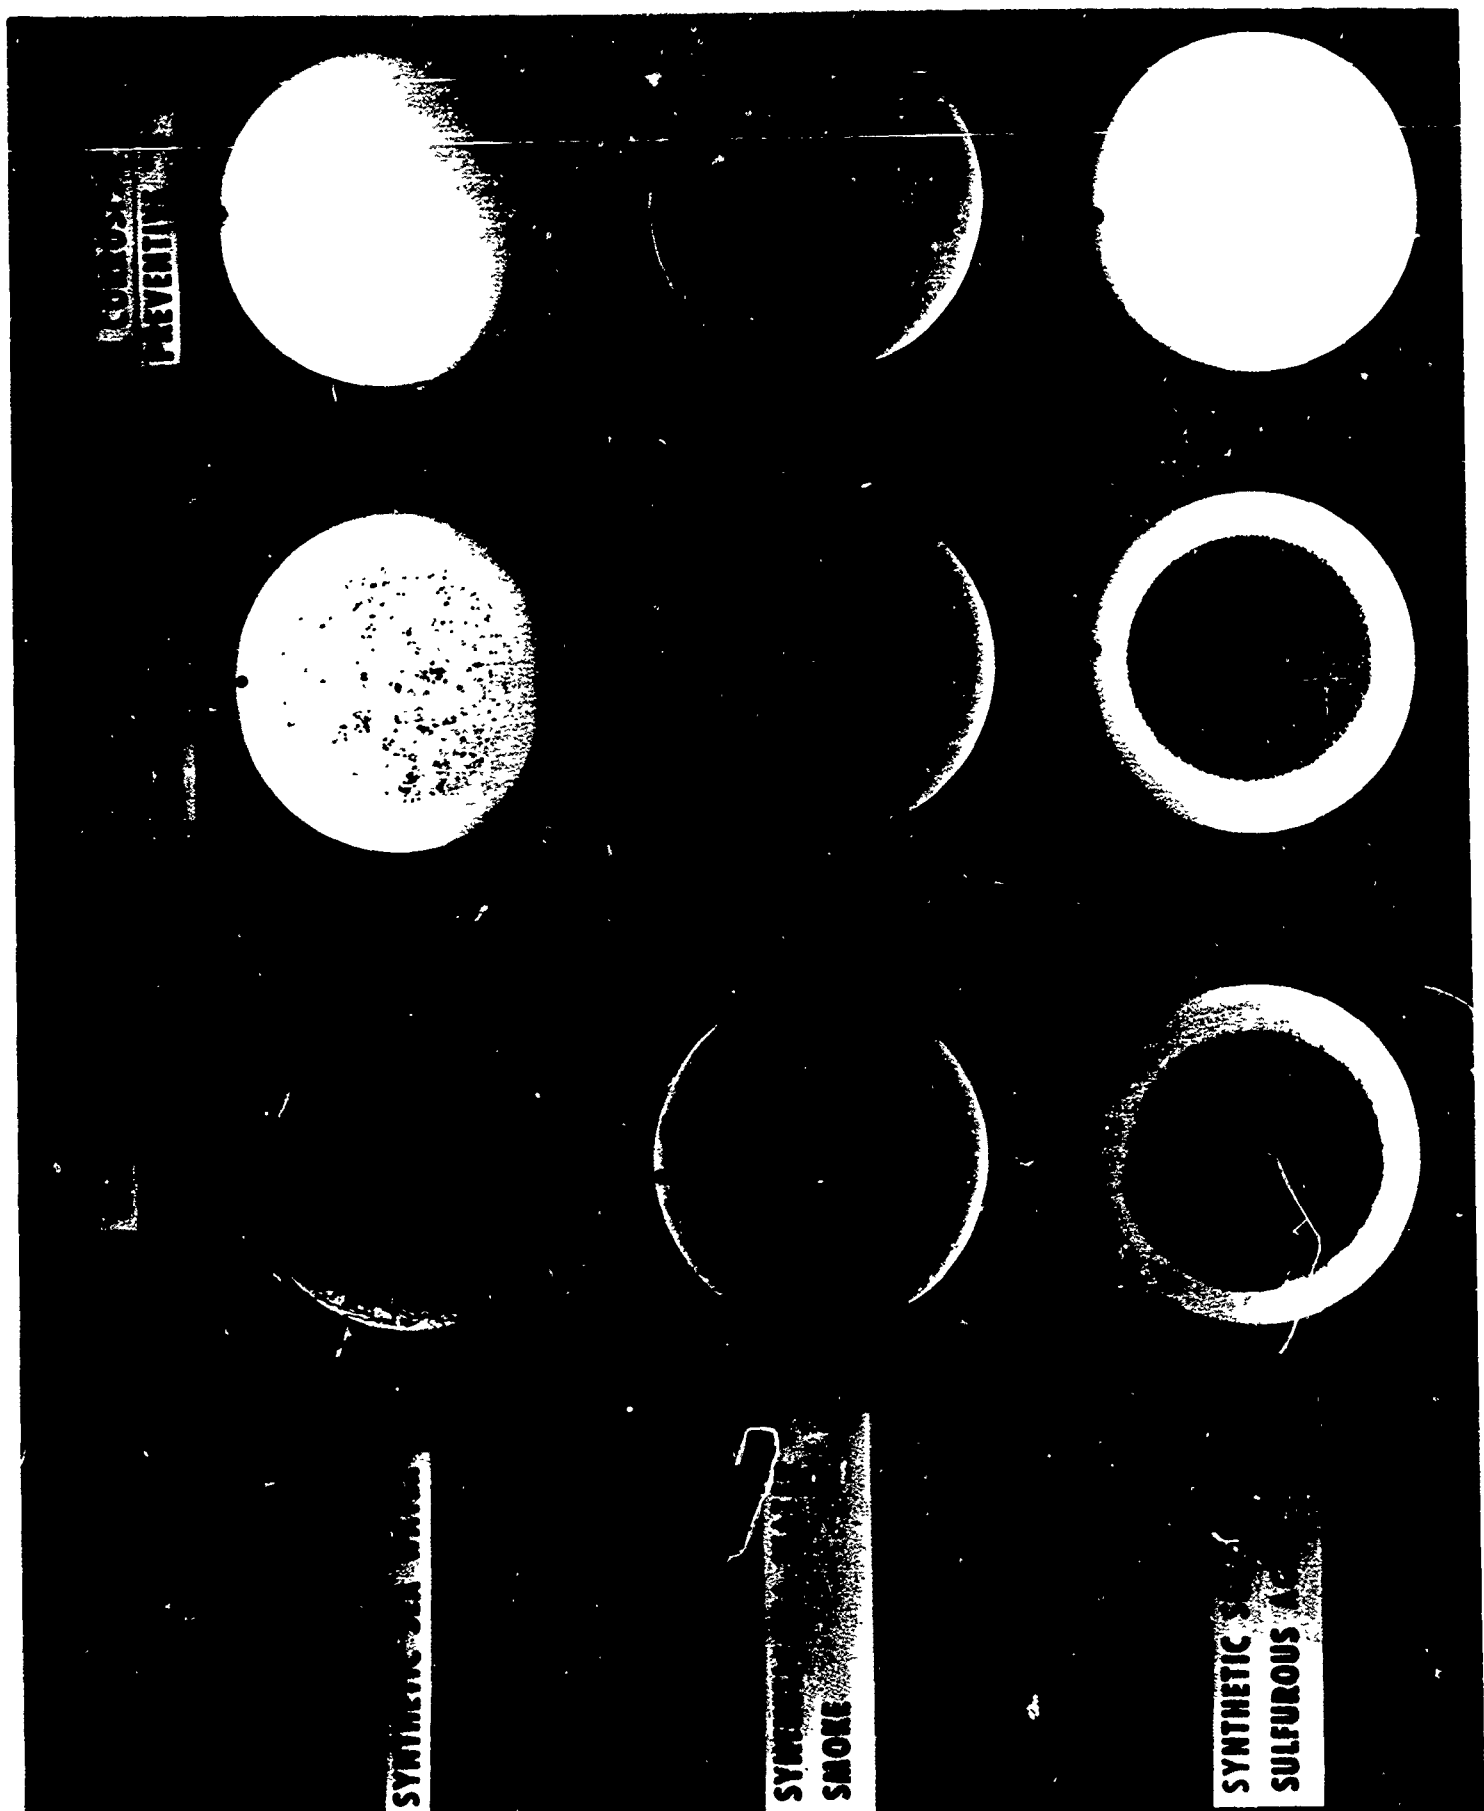
PLATE 8

RESULTS OF EXPOSURE OF STEEL SPECIMENS TO SYNTHETIC SEA WATER,
SYNTHETIC SEA WATER/SMOKE, AND SYNTHETIC SEA WATER/ACID ENVIRONMENTS

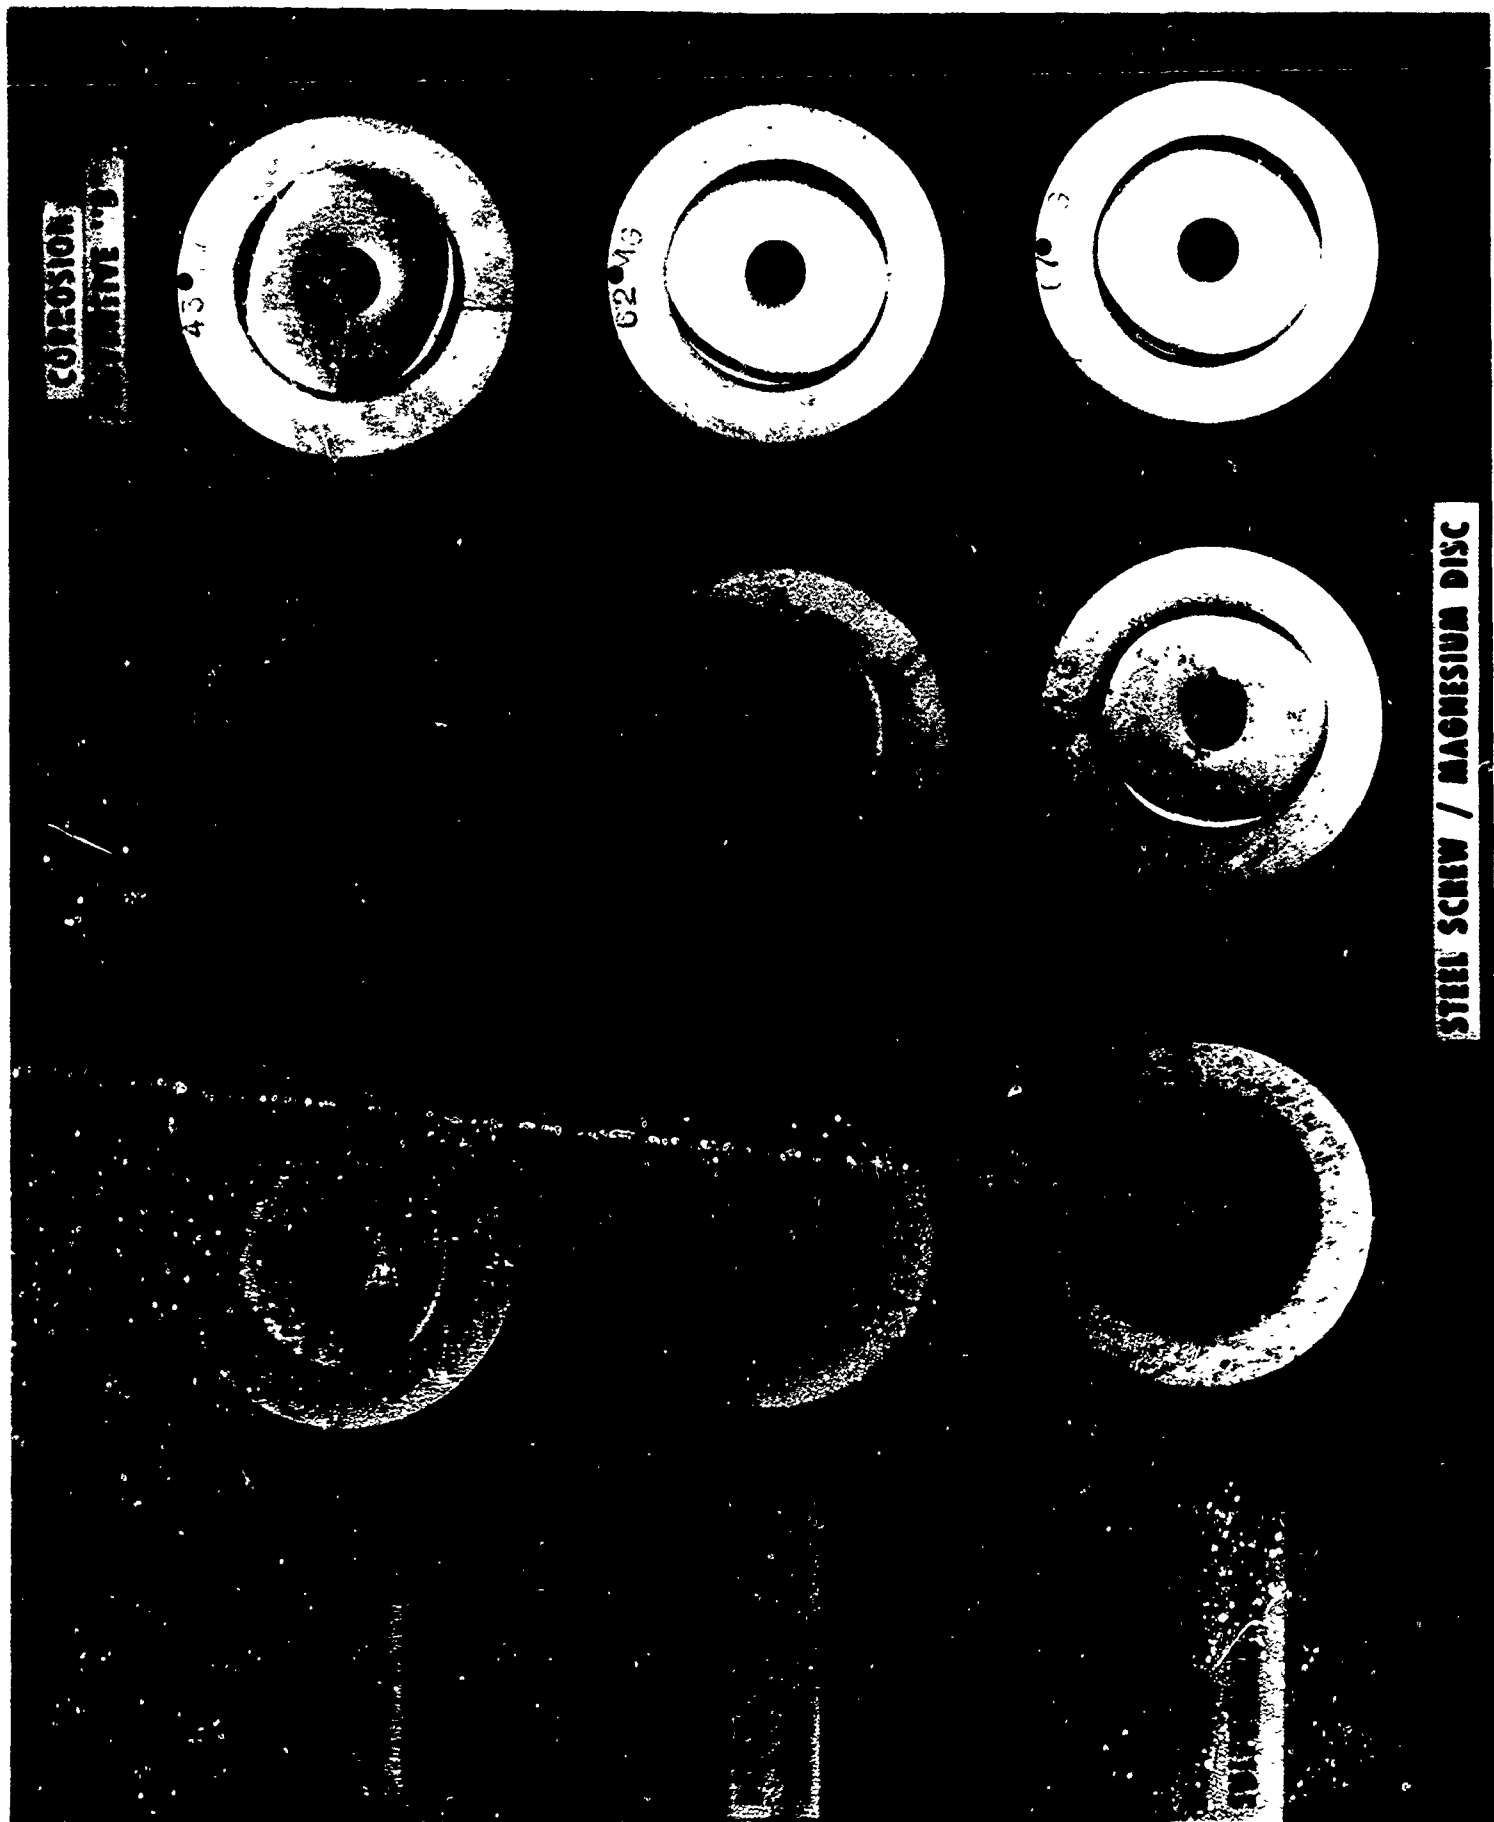
PLATE 9

RESULTS OF EXPOSURE OF DISSIMILAR METAL SPECIMENS TO DISTILLED WATER,
DISTILLED WATER/SMOKE, AND DISTILLED WATER/ACID ENVIRONMENTS

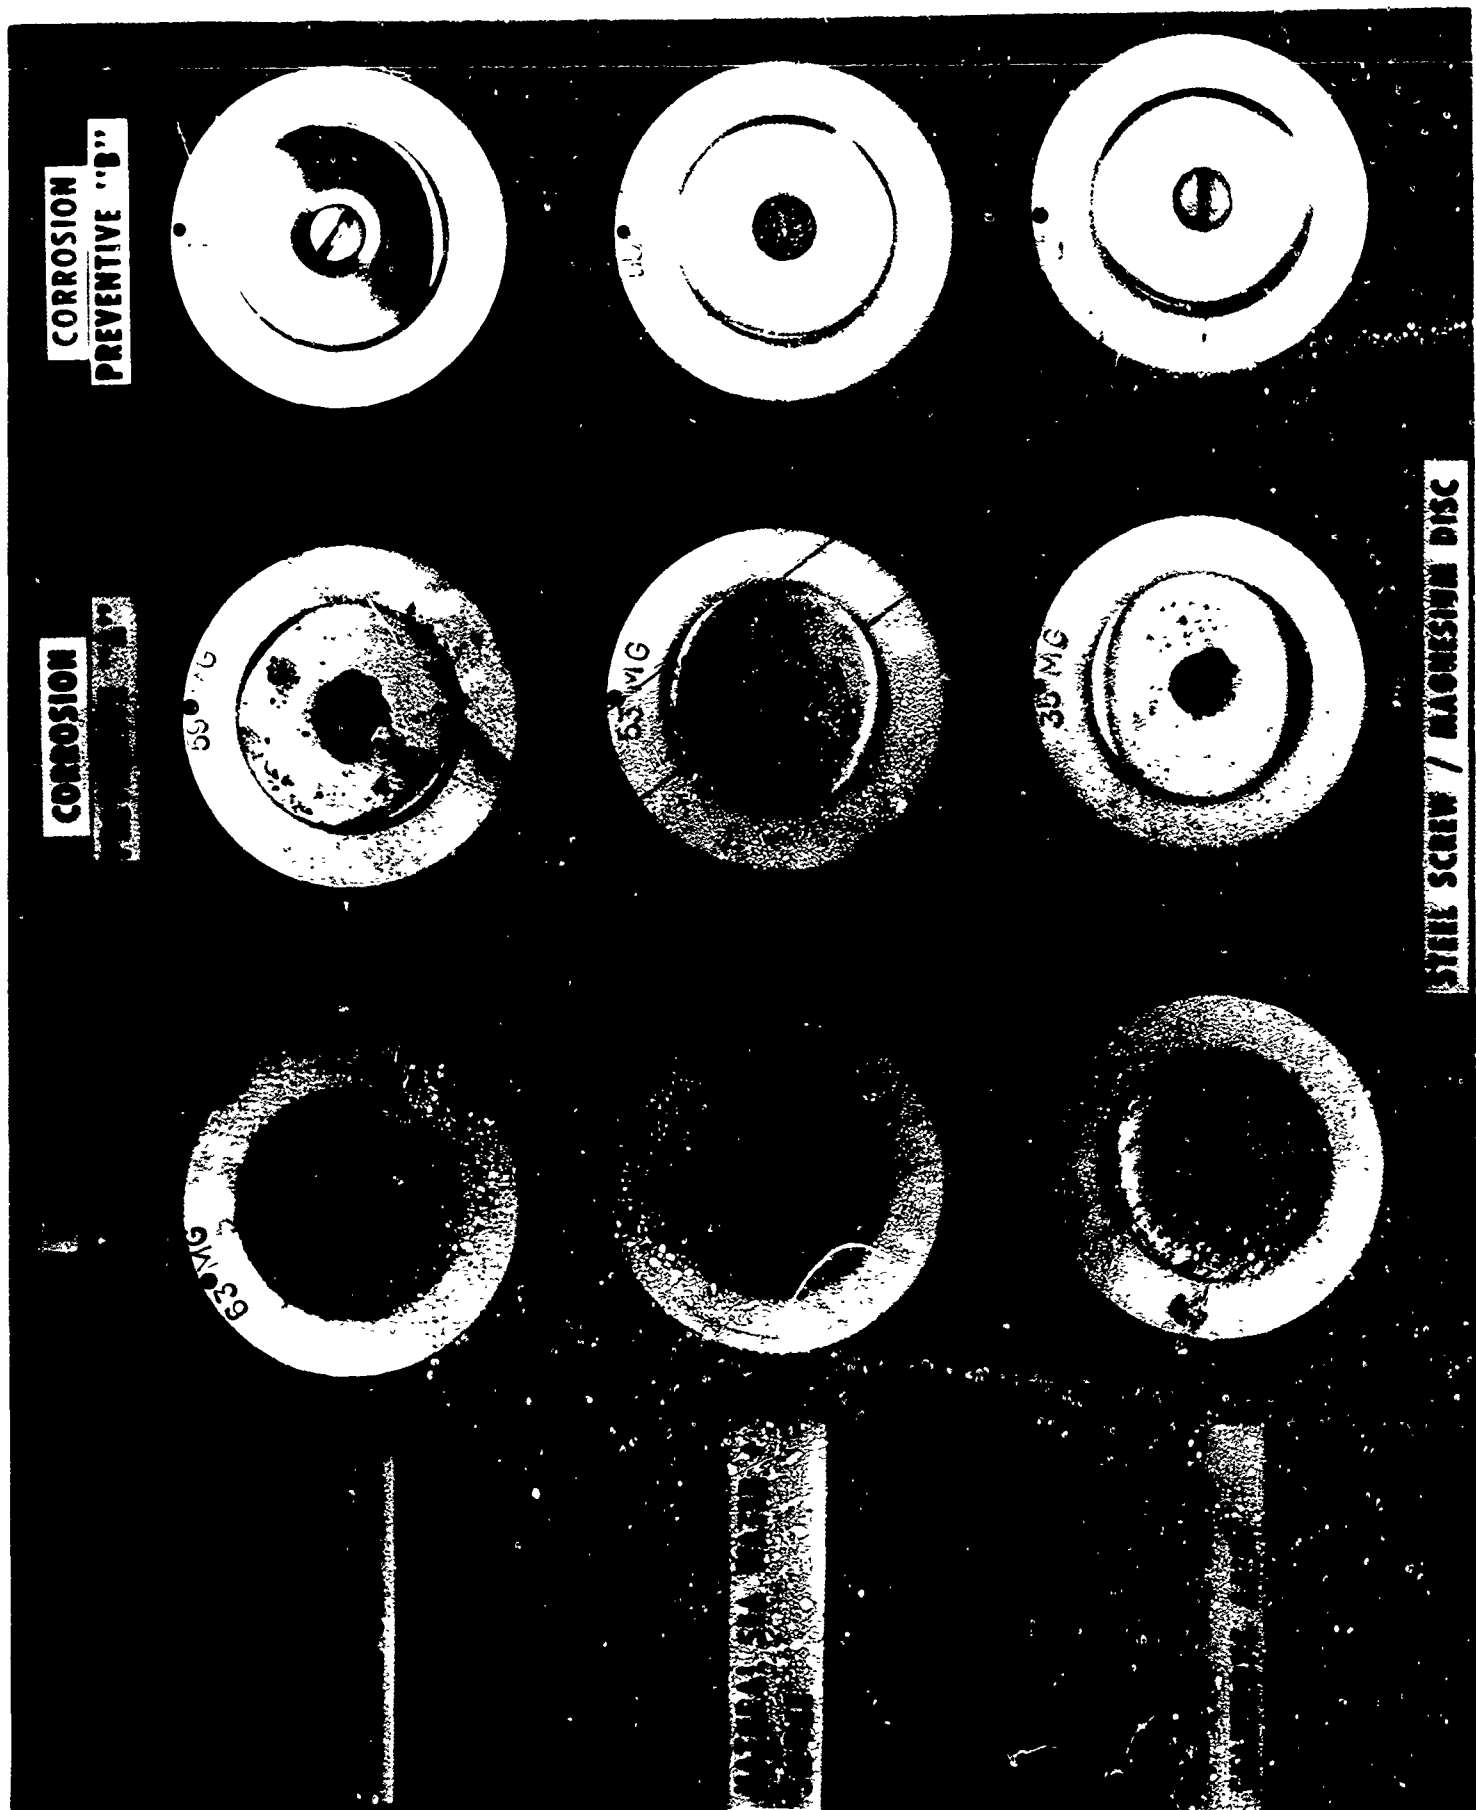
RESULTS OF EXPOSURE OF DISSIMILAR METAL SPECIMENS TO NATURAL SEA WATER, NATURAL SEA WATER/SMOKE, AND NATURAL SEA WATER/ACID ENVIRONMENTS
